Executive Summary

The subsurface check dam was constructed with peoples' participation at Thrangali; a village on the banks of Bharathapuzha situated about 13 km east of the Shoranur town. This check dam is situated on a gentle slope gradient of the river on the down stream of two abuts meandering. This check dam is located on the immediate down stream of the second meandering in the Panchayat. The left bank is occupied by the steeper sloping lateritic massive of the Panjal Panchayat. The right bank has comparatively lesser slope and devoid of any lateritic high in the vicinity. The surface material on the right bank, generally, is recent sand with siliceous material, whereas the left bank is covered either by lateritic crest or lateritic (red) soil. In general it can be said that the right bank is permeable and the left is not. This contrast between the right and left banks persists at least for about 5 km. downstream. There are about 45 open dug wells on the upstream side of the check dam and about 22 well on the down stream. There are a few intake points of lift irrigation system located on the left and right banks upstream.

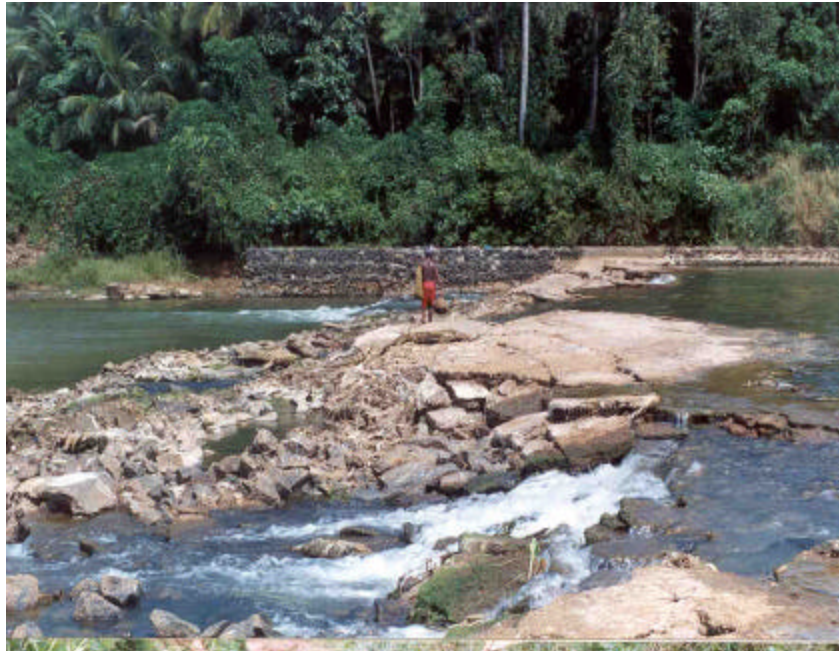
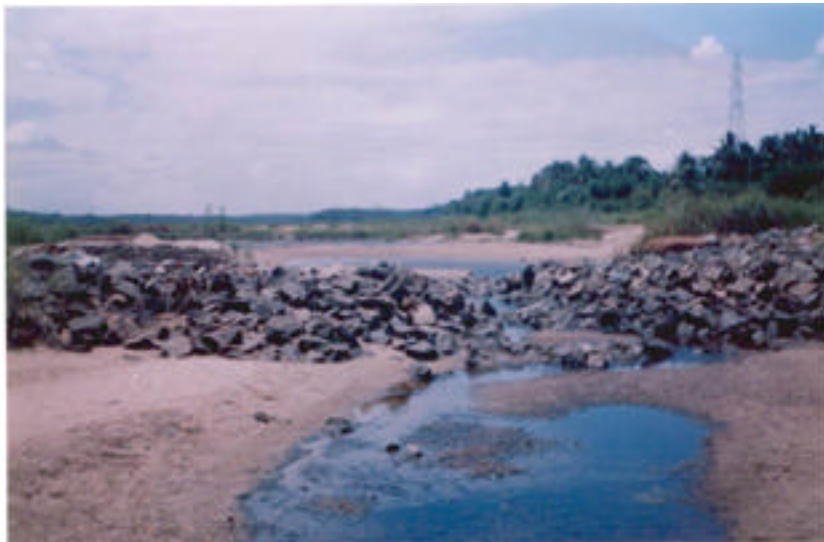
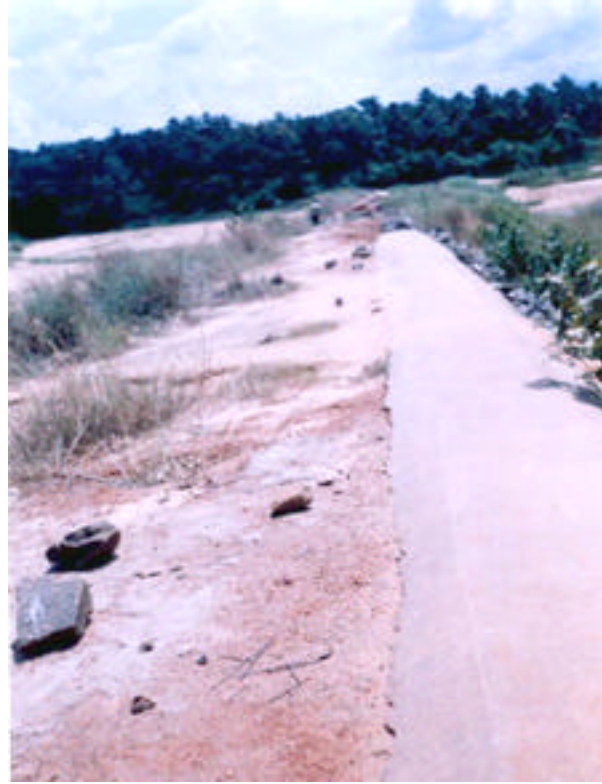
The construction of the subsurface dyke appeared to have created a total maximal flood resistance syndrome, which had resulted in the failure of the surface structure. The structural damage was noticed as early as the monsoon of the year 2000. With the failure of the structure, the very objective of the project which was to monitor the benefits of the subsurface check stood defeated. However, monitoring of the wells was continued in order to ensure if the remnant structure has any effect on the ground water level fluctuation. The hydrographs constructed fail to indicate any such influence of the check dam remnants either. Therefore, no meaningful inference could be made and the raw data on the water level fluctuation observed in all the 42 observation wells is tabulated

However the damage of the check dam had affected the efficiency and so had not been able to achieve the objectives.

Extend of damage to the surface and the sub-surface structures are photographically documented and reproduced in the following pages Figs: 1, 2, 3. The damage to check dam had made the inferences of the database difficult. In order to avoid criticisms of over-simplification, those advocating such Indices also suggest that the raw data be provided so as to allow desegregations into component parts and hence facilitate a more subtle interpretation if a reader so desires and so the raw data are produced as such in
